ROUTE	STATE	DISTRICT	SHEET NO.
67	MO	10	217
JOB NO. JOP0931		CONTRACT ID.	
PROJECT NO.		COUNTY WAYNE	
DATE

CULVERT SECTIONS
SHEET 20 OF 41

Subject Re: Fw: VE J0P0931 - box culvert modifications

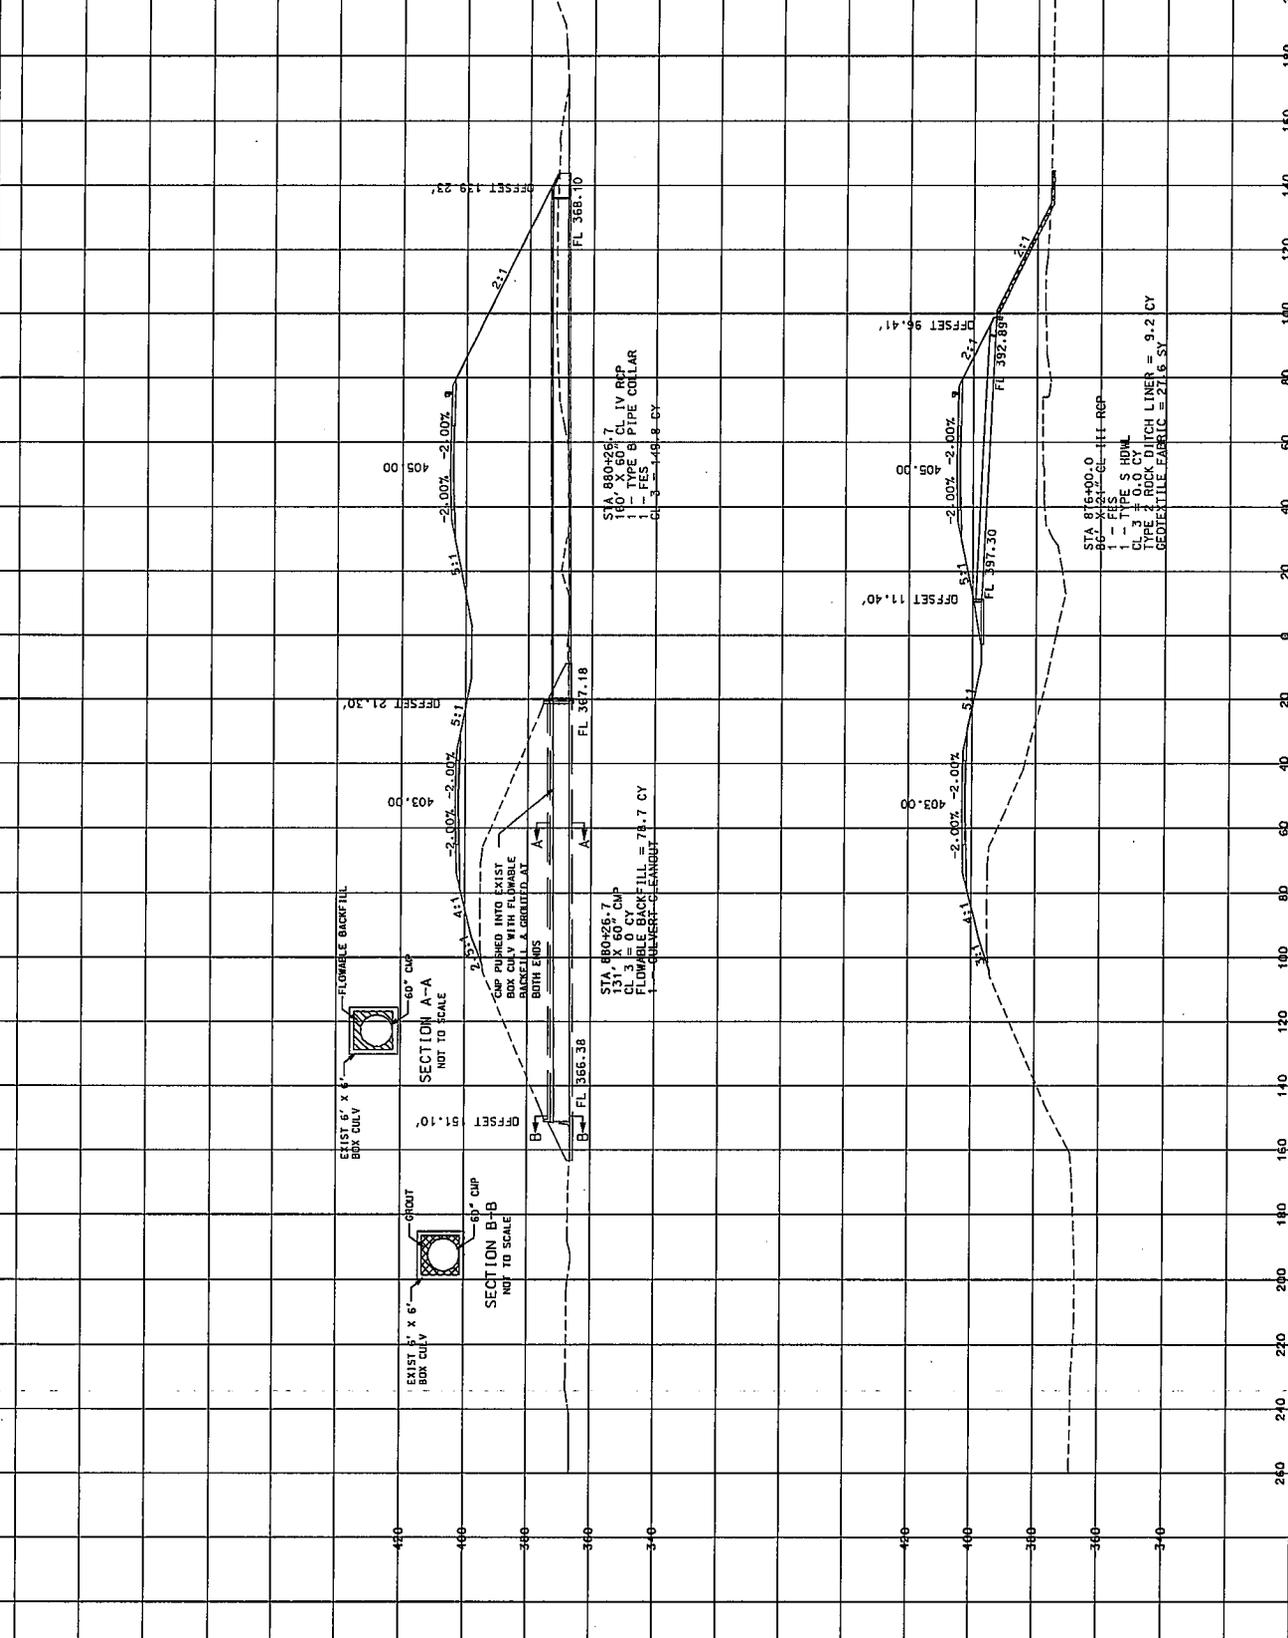
880+26.7000

876+00.0000

Comments: I RECOMMEND THIS PROPOSAL BE REJECTED. THE EXISTING CULVERTS @ STA 880+26.7 & 736+02.5 ARE STRUCTURALLY DEFICIENT TO HANDLE THE ADDITIONAL FILL PLACED ON THEM. THE CMP INSERTS AND FLOWABLE FILL IDENTIFIED WERE CHOSEN AS THE MOST COST EFFECTIVE SOLUTION. OTHER SOLUTIONS PROPOSED DURING DESIGN PHASES WERE LIGHTWEIGHT FILL, BUT PROVED TO BE MUCH MORE COSTLY.

I agree with the rejecting the proposal. These boxes were not designed for the additional fill that is being placed on them. They were checked for the new fill height and they were found to be overstressed. The additional fill would make them structurally unsound.

I suppose if someone would be willing to get in the circa 1927 8'x6' segment and determine if any observed cracking is due to serviceability issues or overloading from additional fill and then perform the structural calculations to support leaving it alone, taking into account future increases in traffic, I would be willing to go along with under-running the length of CMP and backfill by stopping at the 4'x3' transition to a 8'x6' and forming a wall at that location to hold the backfill. Whoever completes that analysis would probably want to seal that sheet.
